SAS Superstructure

Daily Diary Report by Bid Item

Diary #: 426 Const Calendar Day: 780 Date: 28-Oct-2011 Friday

04-0120F4
04-SF-80-13.2/13.9
Self-Anchored
Suspension Bridge

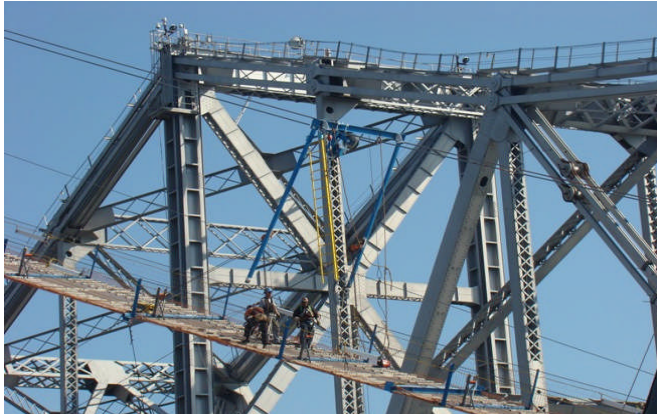
ABF ironworkers placing a tramway frame on the E-Line backspan tramway cables prior to connecting to the catwalk.

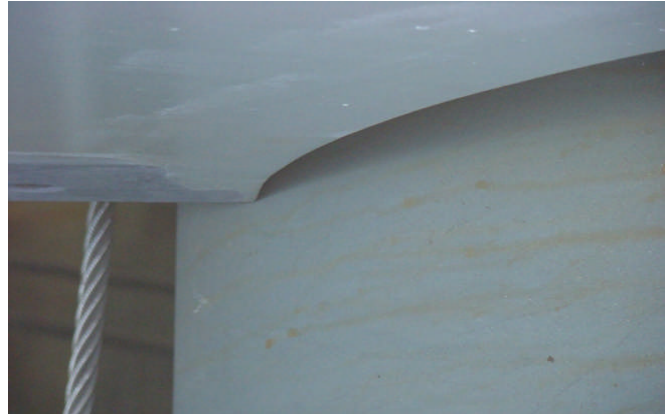
Back plate of OBG lift 14W was touching the Hinge A pipe beam on the south side of the pipe after placement onto the W-Line temporary truss.

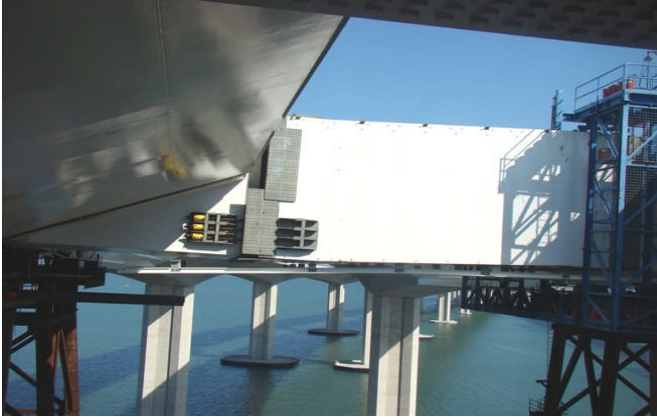
Crossbeam number 19 seen from the E2 cap beam looking east with splice plates and jacks/rods for the jacking operation in place.

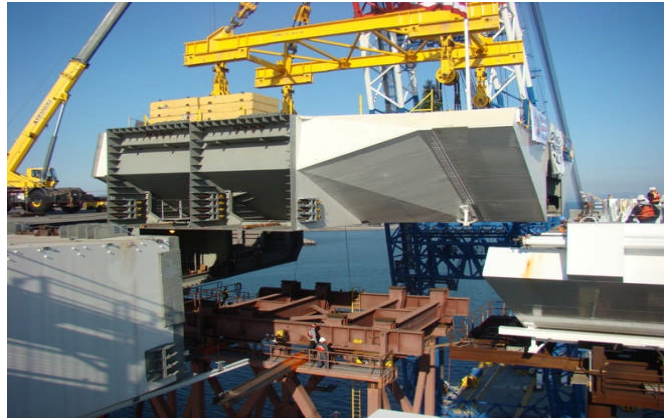
The Left Coast Lifter in the process of placing OBG lift 14W onto the cradle set on the W-Line temporary truss seen from OBG lift 14E.

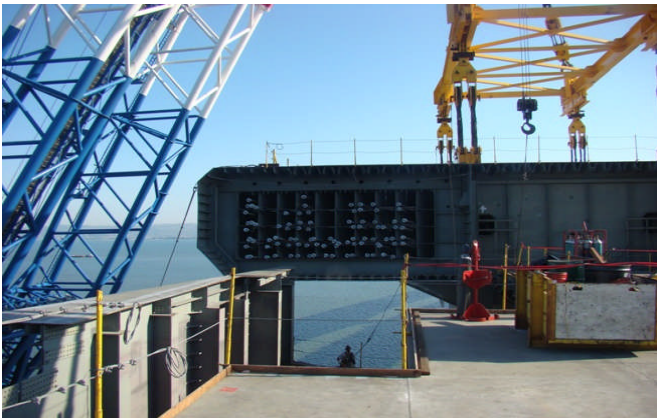
The Left Coast Lifter in the process of placing OBG lift 14W with PWS anchor rods seen from OBG lift 13W.

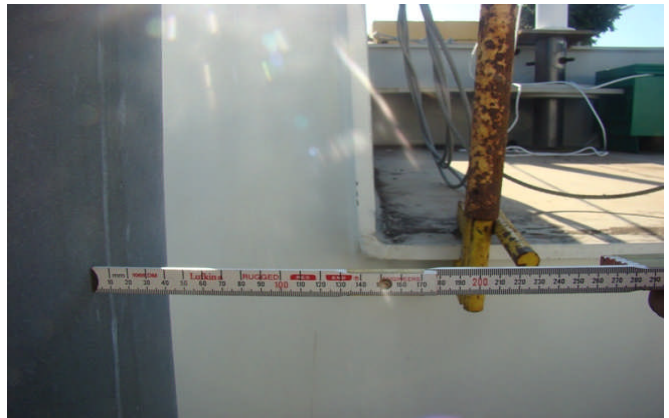
Horizontal offset distance of approximately 145mm from the westbound Skyway and OBG lift 14W after initial placement of the deck section.

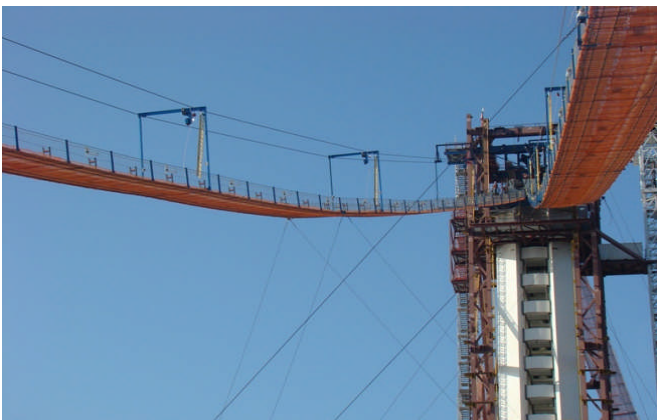
Altered profile of the mainspan catwalks since the tramway frames have been erected.

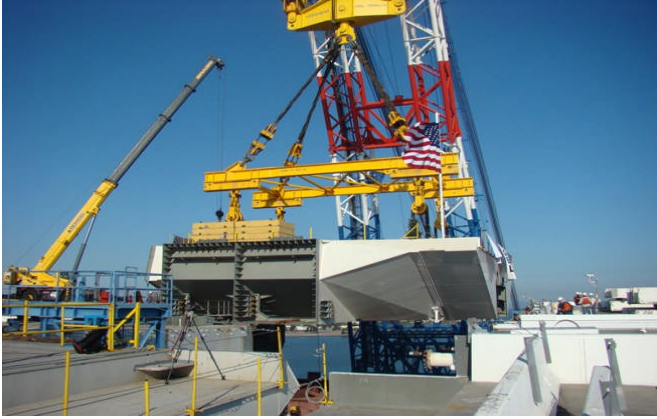
The Left Coast Lifter in the process of placing OBG lift 14W onto the cradle set on the W-Line temporary truss seen from the eastbound Skyway.

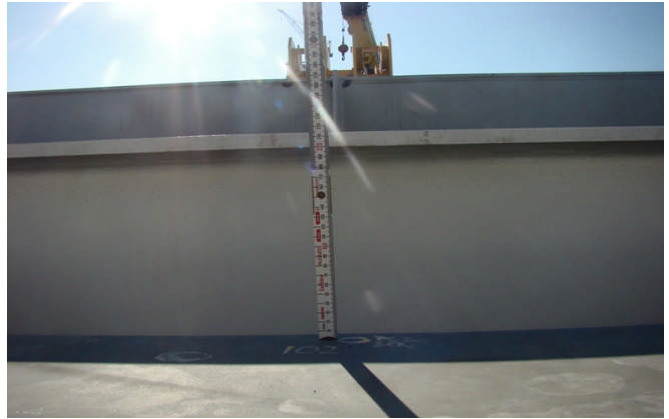
Vertical offset distance of approximately 215mm from the westbound Skyway and OBG lift 14W after initial placement of the deck section.

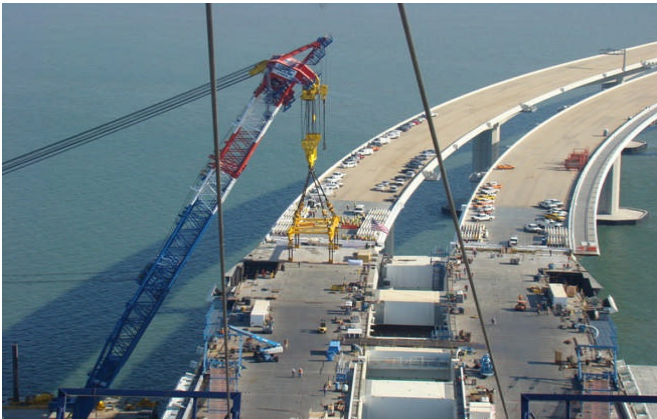
The Left Coast Lifter in the process of placing OBG lift 14W onto the cradle set on the W-Line temporary truss seen from the tower saddle.

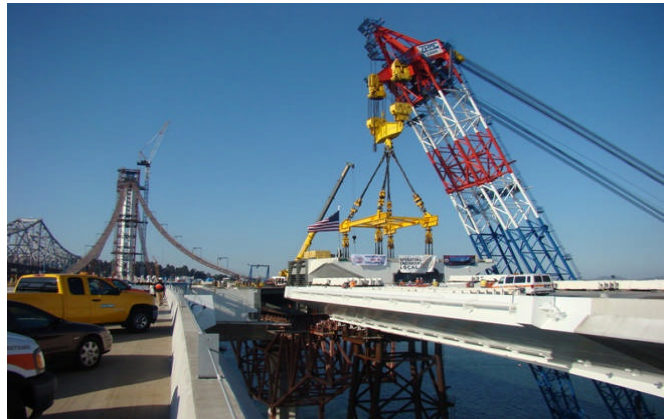
The Left Coast Lifter in the process of placing OBG lift 14W onto the cradle set on the W-Line temporary truss seen from the eastbound Skyway.
